**SITE ASSESSMENT REPORT
FOR THE
VENTURE RIM PRODUCTS SITE
OMMERCE TOWNSHIP, OAKLAND COUNTY, MICHIGAN
TDD: T05-9406-001
PAN: EMI1380SAA
DOCUMENT CONTROL NUMBER: TAT-05-23-0402**

August 25, 1994

ATTACHMENT A
SITE PHOTOGRAPHS

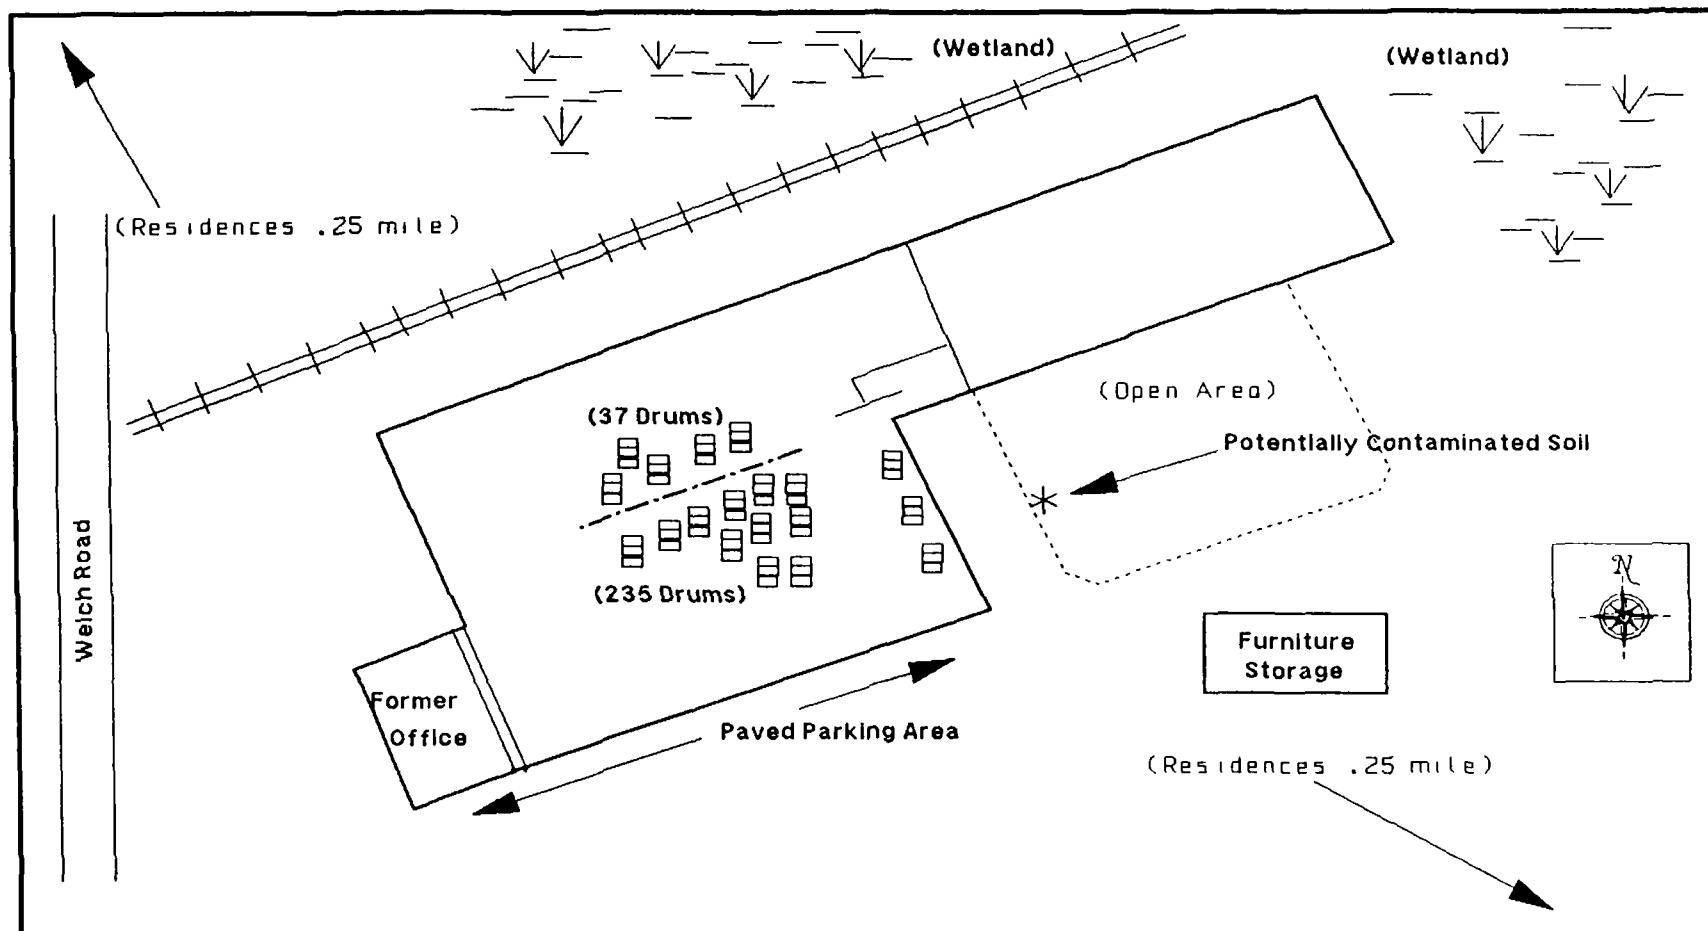
FIGURE 2

The Commerce Township Fire Department, under Chief Ronald Bolitho, had responded to an on-site fire on May 27, 1994, which destroyed the 1,600 square-foot office space at the site. Approximately 20 of 235 drums found in the adjacent warehouse were potentially exposed to high temperature caused by the fire. Another 37 empty drums were found staged in an adjacent room, apparently unaffected by the fire (Figure 2).

The main building's southwestern interior was divided by a wall into two rooms. Approximately 280 drums of hazardous substances were found in these two rooms; many drums were damaged and leaking. Most drums carried labels stating that the contents were poly (oxyalkylene) polyol or methyl-diisocyanate (MDI). The building's northeast section contained some pieces of process equipment and debris. MDNR officials found an apparent contamination stain on soil in the open area at the building's southeastern quarter (Figure 2). Later inspections proved that contaminants had not flowed outside the building.

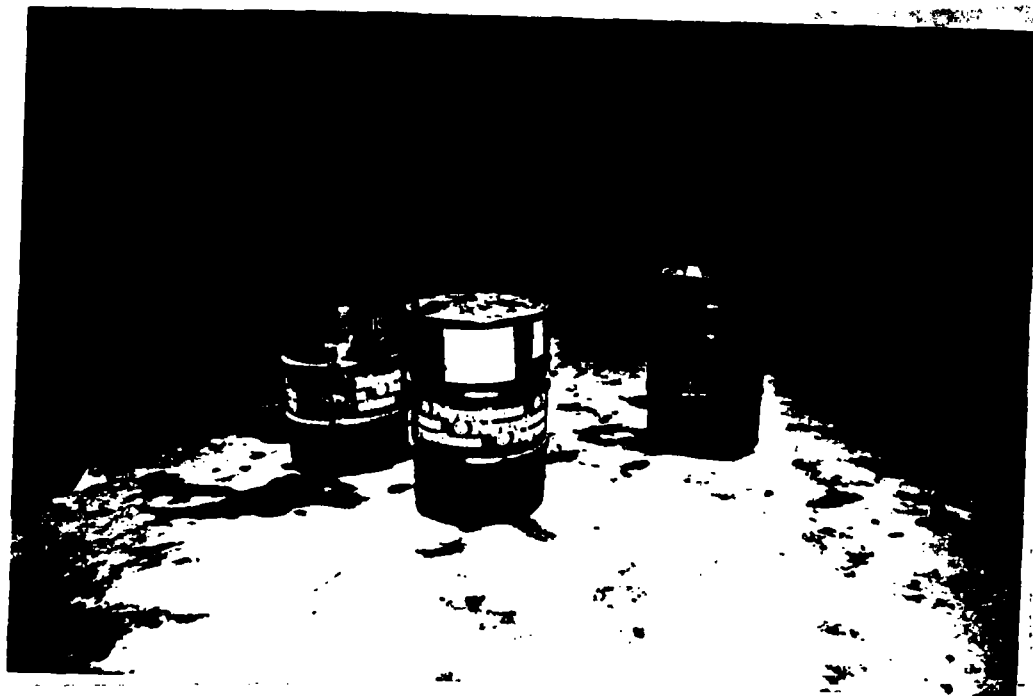
SITE: VENTURE RIM PRODUCTS TDD: T059406001 PAN: EMI1380SAA
DATE: 06.06.94 DIRECTION: NORTHEAST PHOTOGRAPHER: SLB
DESCRIPTION: DRUMS AT EAST END OF MAIN BUILDING.

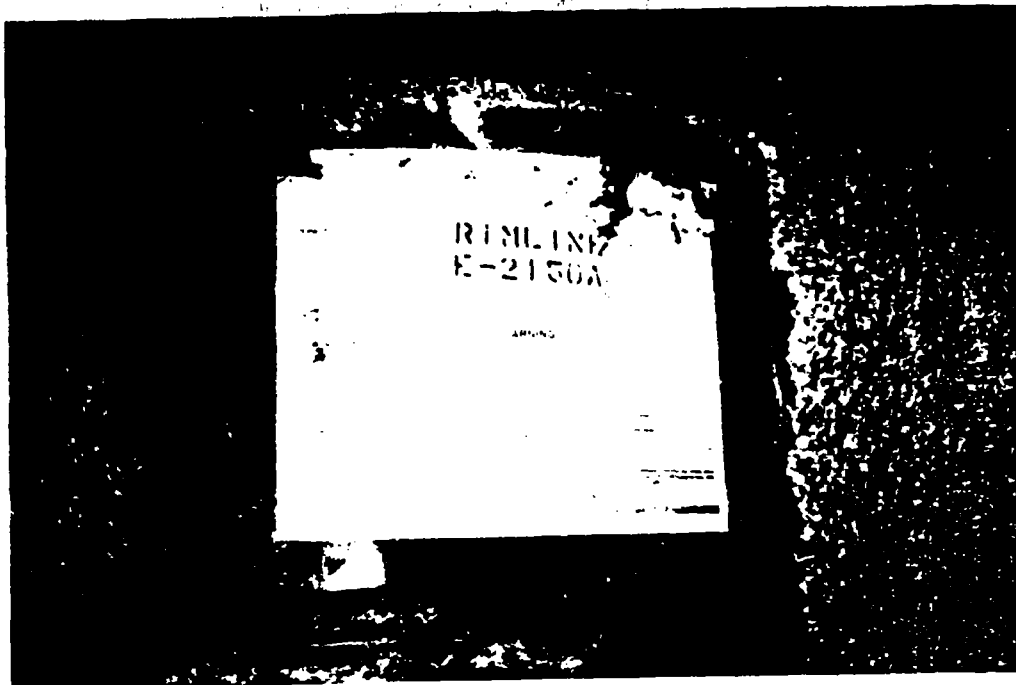
SITE: VENTURE RIM PRODUCTS TDD: T059406001 PAN: EMI1380SA
DATE: 06.06.94 DIRECTION: PHOTOGRAPHER: SLB
DESCRIPTION: DRUM LABEL, "MODIFIED METHYLENE DIPHENYL
DIISOCYANATE".

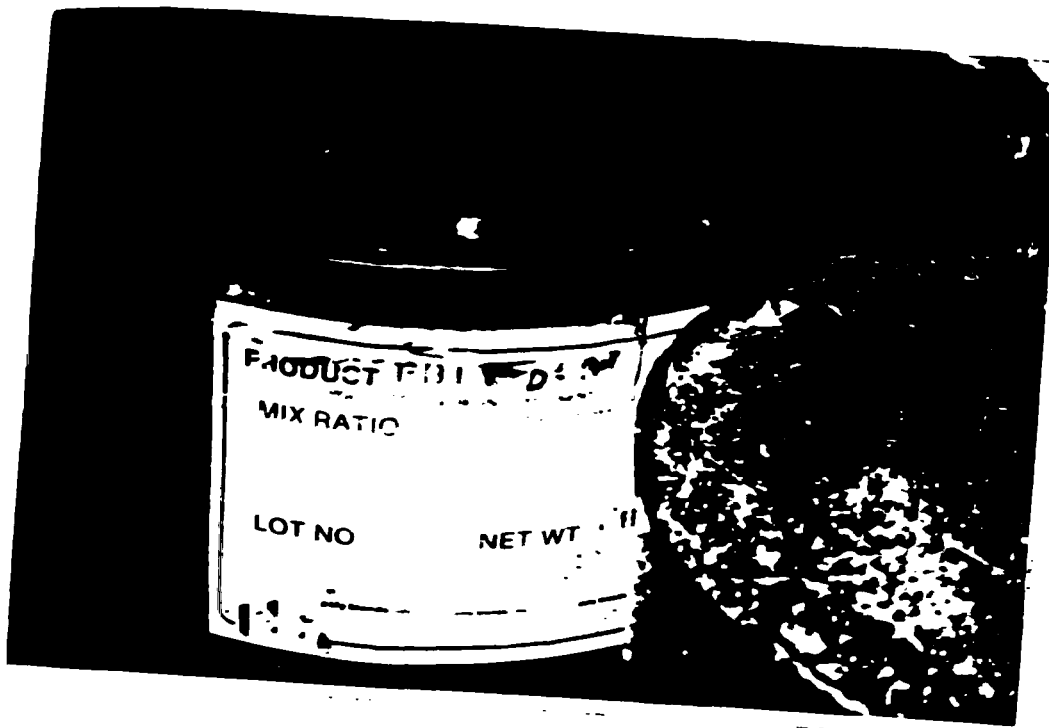
SITE: VENTURE RIM PRODUCTS TDD: T059406001 PAN: EMI1380SAA
 DATE: 06.06.94 DIRECTION: PHOTOGRAPHER: SLB
 DESCRIPTION: LABELS ON DRUMS IN GROUP OF 37 (MDI).

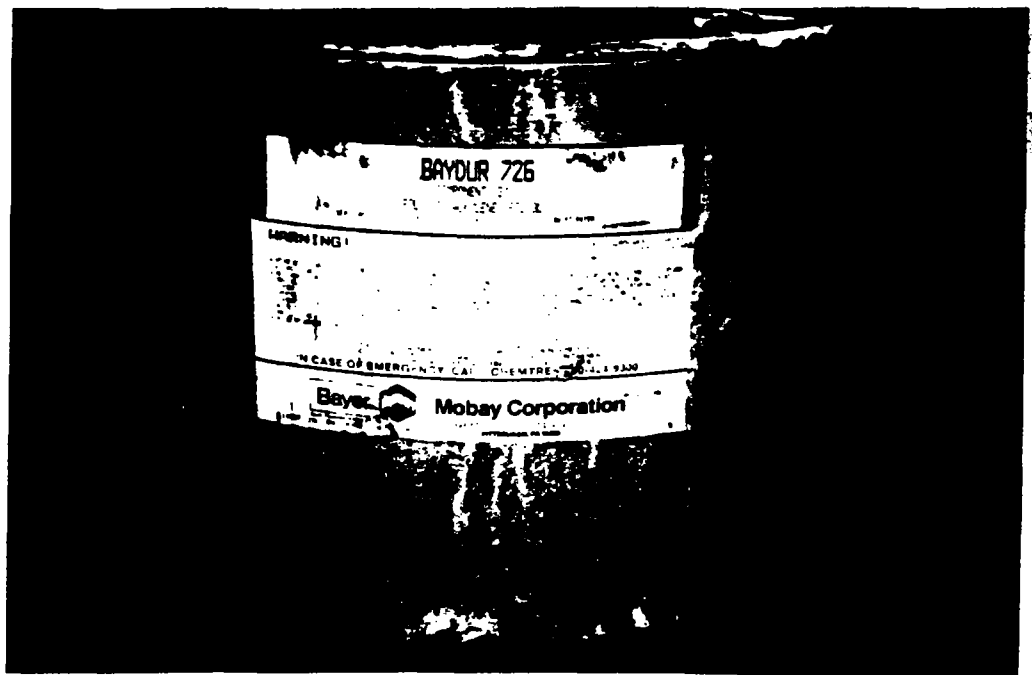
SITE: VENTURE RIM PRODUCTS TDD: T059406001 PAN: EMI1380SAA
DATE: 06.06.94 DIRECTION: PHOTOGRAPHER: SLB
DESCRIPTION: LABEL ON LEAKING DRUM AT THE NORTHEAST LOADING
BAY/OVERHEAD DOOR.

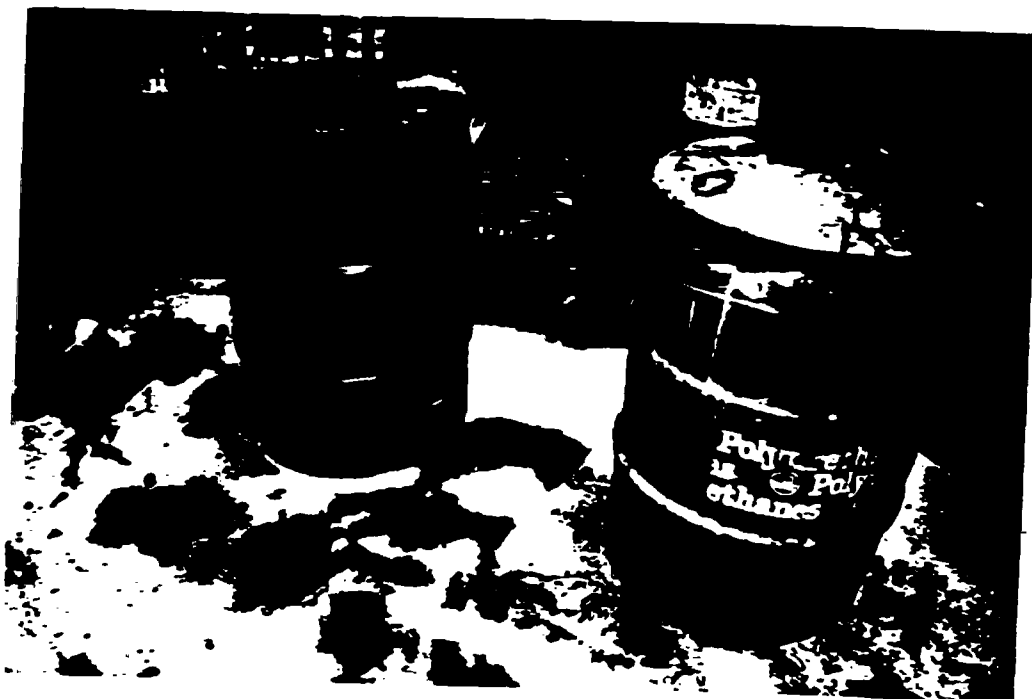
SITE: VENTURE RIM PRODUCTS TDD: T059406001 PAN: EMI1380SAA
 DATE: 06.06.94 DIRECTION: PHOTOGRAPHER: SLB
 DESCRIPTION: SPILTH AROUND DRUM OF POLYOL.
